PHOTOGRAPHIC INTERPRETATION REPORT

SIGNIFICANT RAILROAD BRIDGE AND RAIL YARD RESTORATION

NORTH VIETNAM

NPIC/R-68/69 AUGUST 1969

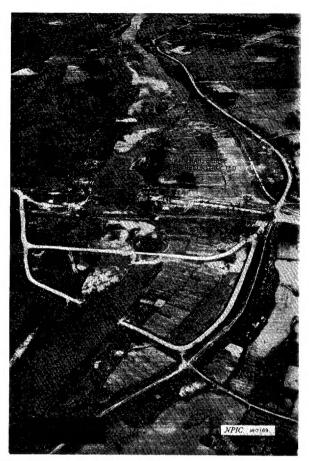
FIGURE 4. PHUONG DINH RAILROAD AND HIGHWAY BRIDGE OVER THE LACH TRUONG 25X1D

Repair or reconstruction has been observed at 18 of the 28 significant river crossings covered in this report. The rail bridges at Lao Cai and Thanh Hoa were never destroyed by airstrike (Figure 1 and Table 1). At eight locations the original bridge remains unserviceable with no reconstruction evident and temporary bypass rail bridges are still in use. Bridges at 14 locations have been replaced at the site of the original destroyed bridge (Figures 1-3) and existing bypass rail bridges are being maintained at some of these sites. Bridges are being reconstructed at four original sites and at three of these sites, located north of Vinh, adjacent bypass rail bridges remain operational (Figure 4).

4 Dong Muc Railroad Bridge over the Song Thuong	21-27-16N 106-14-13E	Original bridge is operational. One bypass rail bridge is probably operational.	18	Phuong Dinh Railroad/High- way Bridge over the Lach	19-51-03N 10)5-48-17E	25.81	Original bridge is being reconstructed. Two bypass rail bridges are operational.
5 Ha Gia Railroad Bridge over the Song Cong	21-19-36N 105-52-40E	Original bridge is reconstructed and operational. One bypass rail bridge is unserviceable.	19	Truong Thanh Hoa Railroad/Highway Bridge over the Song Ma	19-50-12N 10	05-47-54E	4	Original bridge is operational (bridge was never completely destroyed by airstrikes).
6 Viet Tri Railroad/Highw Bridge over the Riviere Claire	ay 21-17-55N 105-26-58E	rail bridges are observed.		Thi Long Railroad Bridge over the Suci Cay Gang	19-31-50N 10	05-42-50E		Original bridge is probably being reconstructed. One bypass rail bridge is operational and one is un- serviceable.
